*SUSTAINABLY DEVELOPING THE OUTBACK*

# **DIAMANTINA DRINKING WATER QUALITY MANAGEMENT PLAN**

Service Provider ID 42

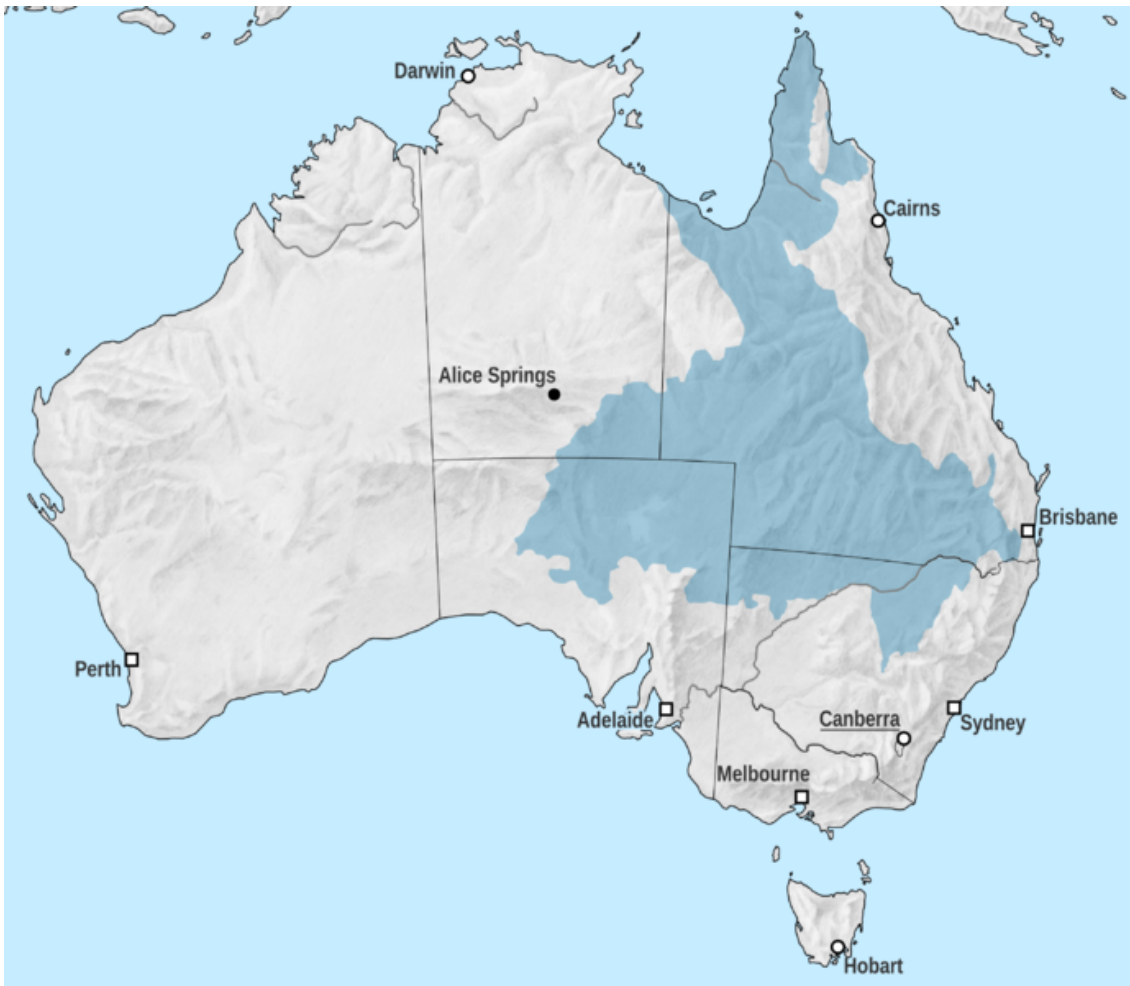
The potable water supply for both towns is sourced from the Great Artesian Basin (GAB), which extends over the blue shaded area on Figure 2 below.

**Figure 2: Great Artesian Basin Area and Location Relative to Queensland.**

The water of the GAB is held in sandstone layers laid down by the continental erosion of higher ground during the Triassic, Jurassic, and early Cretaceous periods, during a time when much of what is now inland Australia was below sea level. The sandstone was then covered by a layer of marine sedimentary rock shortly afterwards, which formed a confining layer - trapping water in the sandstone aquifer. The eastern edge of the basin was uplifted when the Great Dividing Range formed. The other side was created from the landforms of the Central Eastern Lowlands and the Great Western Plateau to the west.

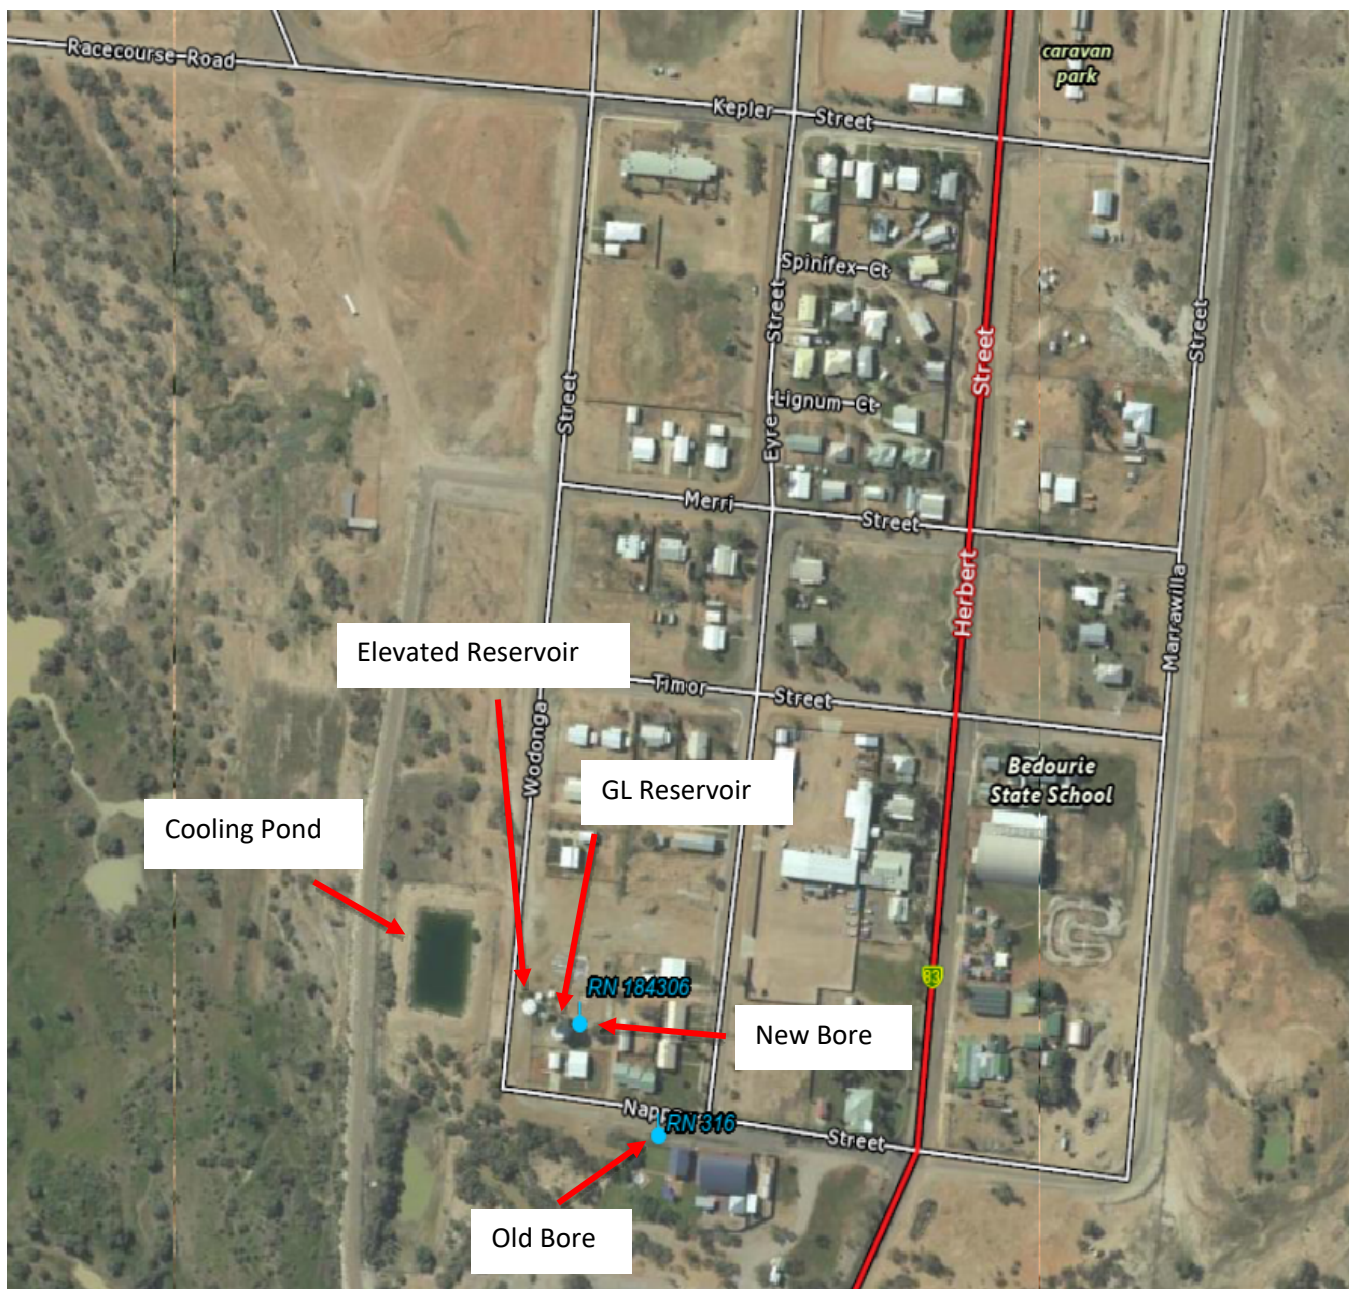
Figure 3: Annotated QLD Globe Image of Bedourie's Drinking Water Infrastructure.

The Bedourie Drinking Water Scheme consists of two deep Artesian bores; Old Bedourie Bore (RN 316) and New Bedourie Bore (RN184306). The Bedourie distribution system was constructed in 1996 and was extended to the industrial area in 2000. The Old Bedourie Bore is located on the southern side of Nappa Street and the New Bedourie Bore is located in a fenced compound on the northern side of Nappa Street. The town is fed by the New Bedourie Bore and the Old Bedourie Bore remains connected as a back-up supply. Neither bore is at significant risk from bushfires, flooding or damage by vehicles or machinery.

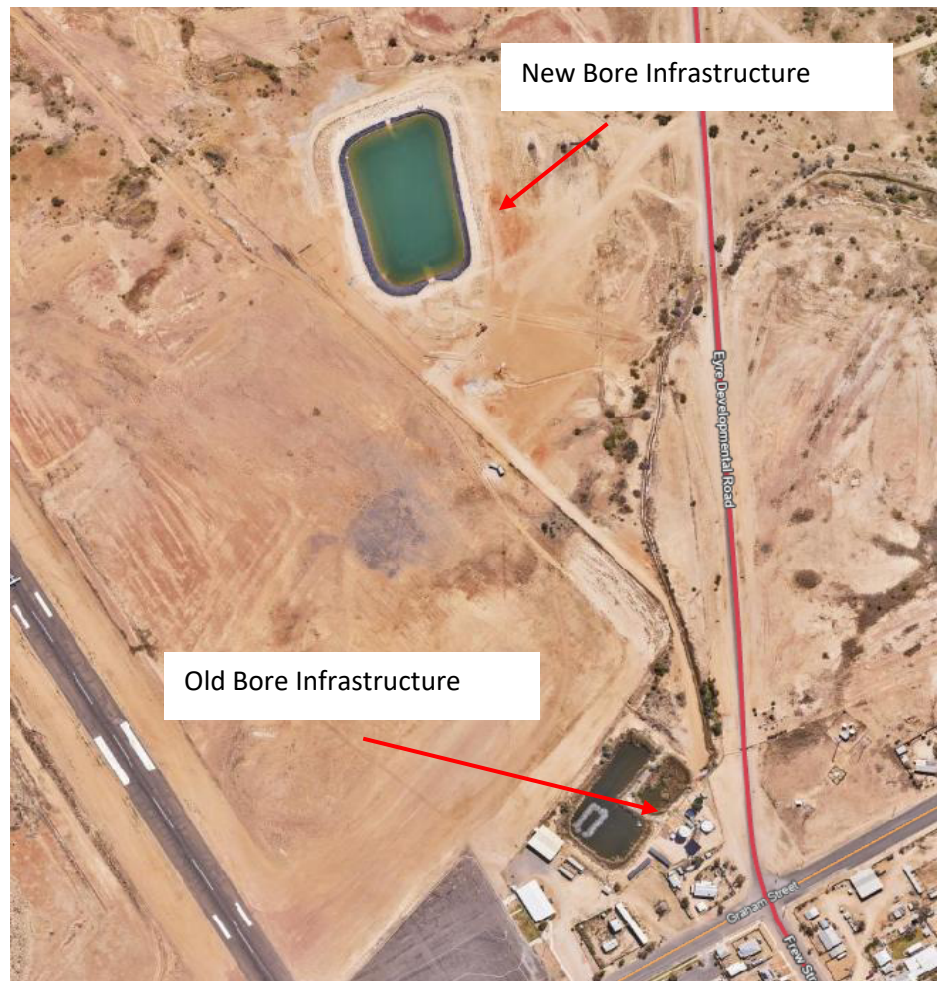
**Figure 10: Location of Birdsville Old Bore infrastructure in relation to the New Bore infrastructure.**
